**YANKTON LIGHTING and HEATING COMPANY #1
YANKTON, SOUTH DAKOTA**

PRELIMINARY ASSESSMENT

DECEMBER 16, 1994

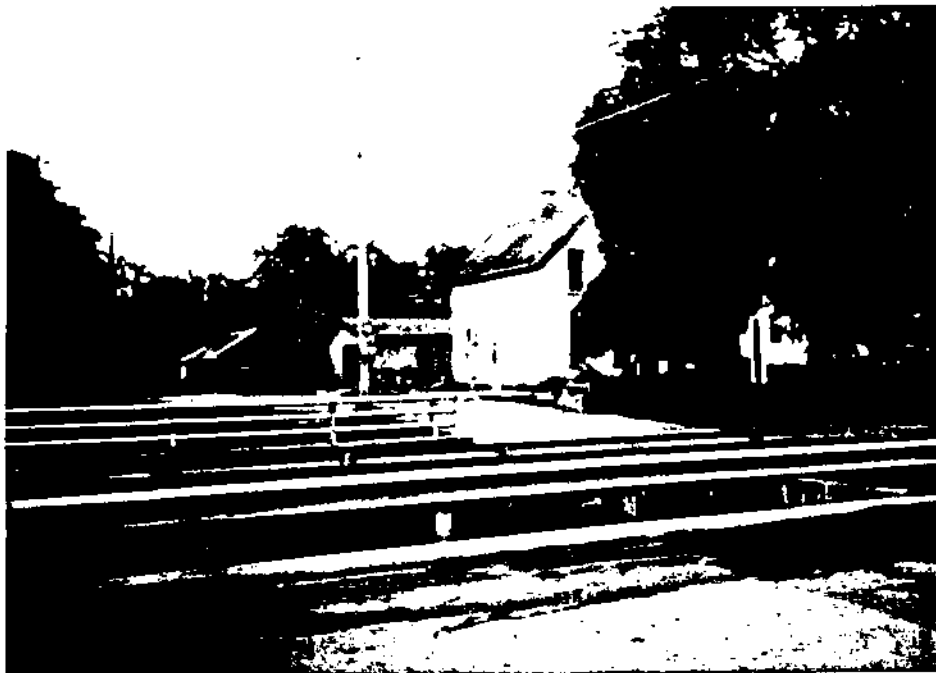
PHOTO 1

It is unknown whether byproducts of gas production were deposited at the Yankton site. No visible evidence of the former gasification plant remains at the site (URS 1993) (photos 1 and 2). The current residents of the property have not observed any signs of the former coal gasification plant (Voracek 1994).

Former location of the Yankton Lighting and Heating Company's first manufactured gas plant. View is to the southeast from Douglas Street.
